# CONCRETECANVAS ROAD CASE STUDIES

Concrete Canvas® is a Geosynthetic Cementitious Composite Mat (GCCM), part of a revolutionary new class of construction materials. It is a flexible, concrete impregnated fabric that hardens on hydration to form a thin, durable, water proof and fire resistant concrete layer. Essentially, it's concrete on a roll. Concrete Canvas® GCCM (CC) is predominantly used for erosion control applications such as ditch lining and slope protection, offering a faster, more cost effective alternative to conventional concrete that reduces the need for road closures.

The following pages contain a collection of case studies highlighting the advantages of using CC for a variety of applications in the road sector.

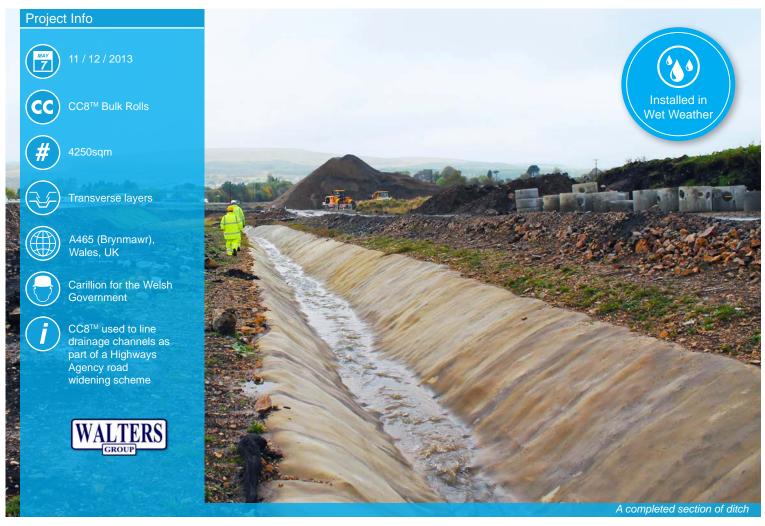
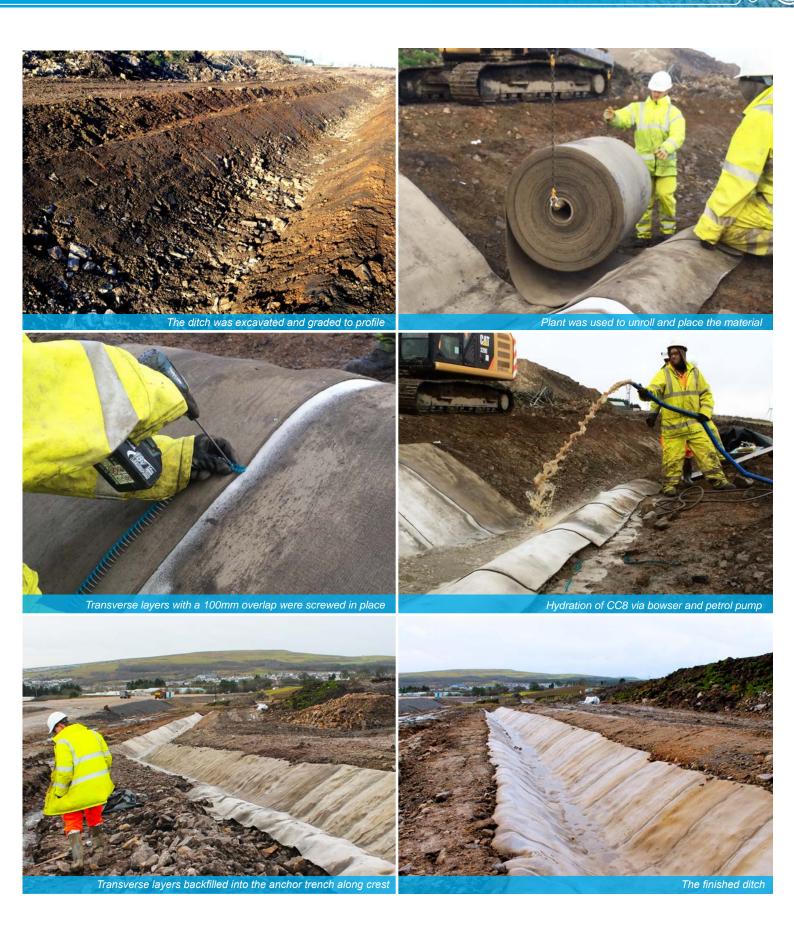
In December 2013, Concrete Canvas GCCM\* (CC) was specified for use in lining drainage ditches along a 7.8km stretch of the A465, between Brynmawr and Tredegar in South Wales. The ditches form part of the A465 Dualling Project, which is part of the National Transport Plan, and will contribute to upgrading links to businesses and communities whilst improving safety.

Primarily commissioned by the Welsh Government, the scheme is under Highways Agency management with Carillion appointed as main contractor who subcontracted Walters UK to complete the principle earth works and pre-earthworks drainage. ARUP provided the design detail specifying CC.

8mm thick CC (CC8<sup>™</sup>) was used to line one main ditch and various smaller ditches on site. The main ditch is approximately 250m in length, 7m in width at the crest of the ditch and 3m wide at the base. 125sqm bulk rolls were deployed using an excavator and spreader beam before being batched to length using hand tools. Subsequent layers were overlapped by 100mm in the direction of the water flow and screwed in place at 150mm intervals. The CC8<sup>™</sup> was installed at a rate of approximately 50sqm per day with a 3 man team (two of the crew laying the material and a third fixing it in place).

Prior to specification of CC8<sup>™</sup>, stone pitching with a paving slab invert was considered as a means of lining the ditch, but this would have resulted in a considerably longer install further delayed by weather conditions. In comparison, CC8<sup>™</sup> provided a significantly faster and easier installation negating any programme disruption due to the weather.

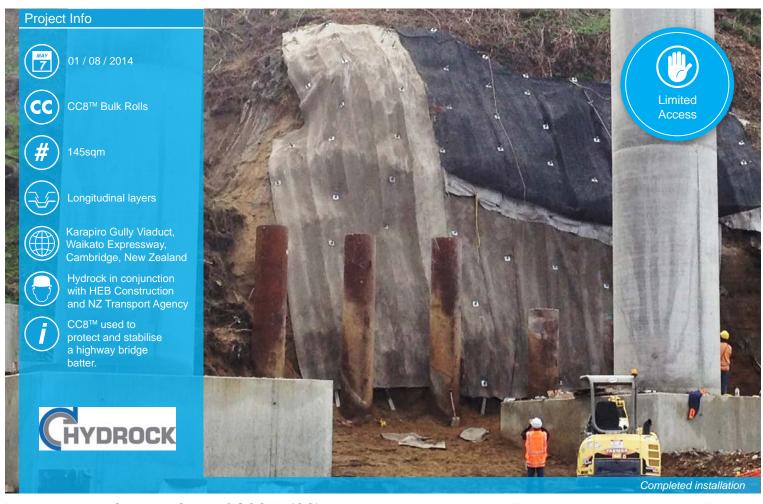
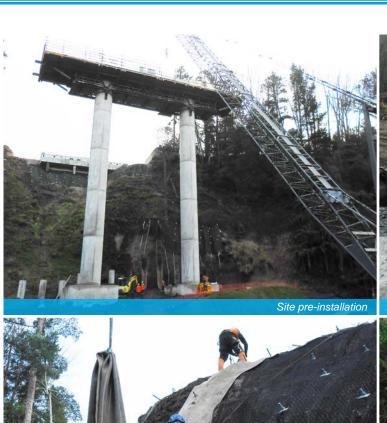
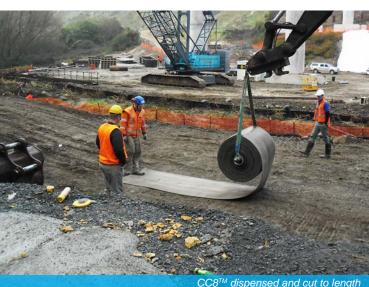
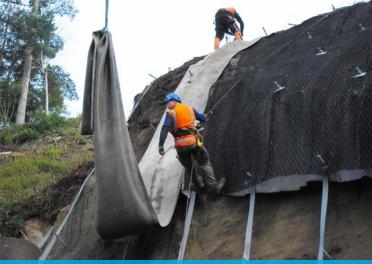
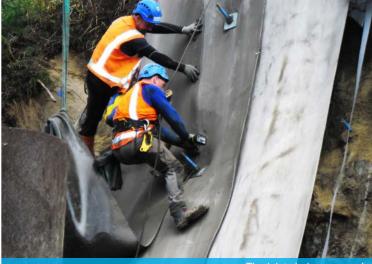
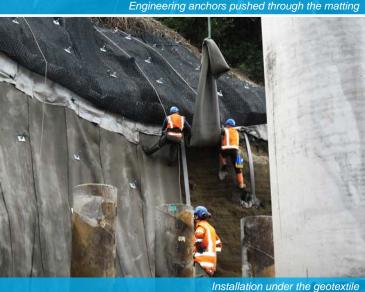
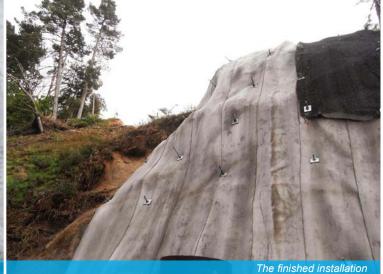
In August 2014, Concrete Canvas® GCCM\* (CC) was used to protect and stabilise a batter underneath the Karapiro Gully Viaduct, Waikato Expressway, Cambridge, New Zealand. The bridge at 200 metres long and 40 metres high required vegetation to be cleared during construction resulting in the batter needing stabilising. Sprayed concrete was considered, but as the site is located in a gully, the limited plant access would have resulted in a much lengthier install. Furthermore the rebound associated with sprayed concrete would have created additional problems.

Installation was carried out by Hydrock in conjunction with HEB Construction for NZ Transport Agency. On the parts of the batter that could be vegetated, a geotextile was laid and hydroseeded. 8mm thick CC (CC8™) was used in conjunction with 12m engineering anchors on the rest of the slope to provide protection and stabilisation. Bulk rolls of CC8™ were delivered to site and dispensed using a digger and a spreader beam, before being cut to length using a disc cutter. Ensuring a 100mm overlap between layers, these lengths were lifted into place by a crane. As the CC8™ was lowered down the slope the soil nails were pushed through and capped, before the overlaps were screwed at 200mm intervals with 25mm screws. Where the CC8™ met the geotextile, the geotextile was lifted up and the CC8™ secured underneath it. The CC was hydrated using a 1000L bowser suspended from the crane and a hose.

145sqm of CC8<sup>TM</sup> were installed by 3 people over 6 hours in damp conditions on a near vertical batter. The site was difficult to access and CC did not require any additional equipment to be brought to site, resulting in large time and cost savings.

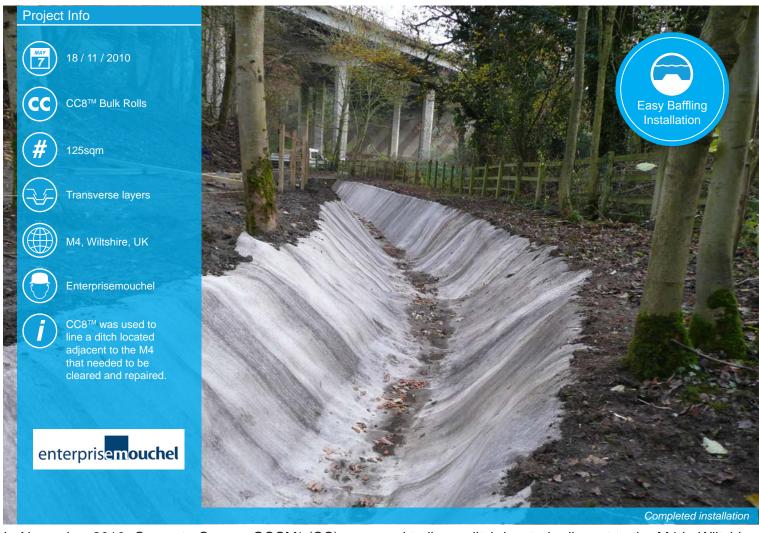
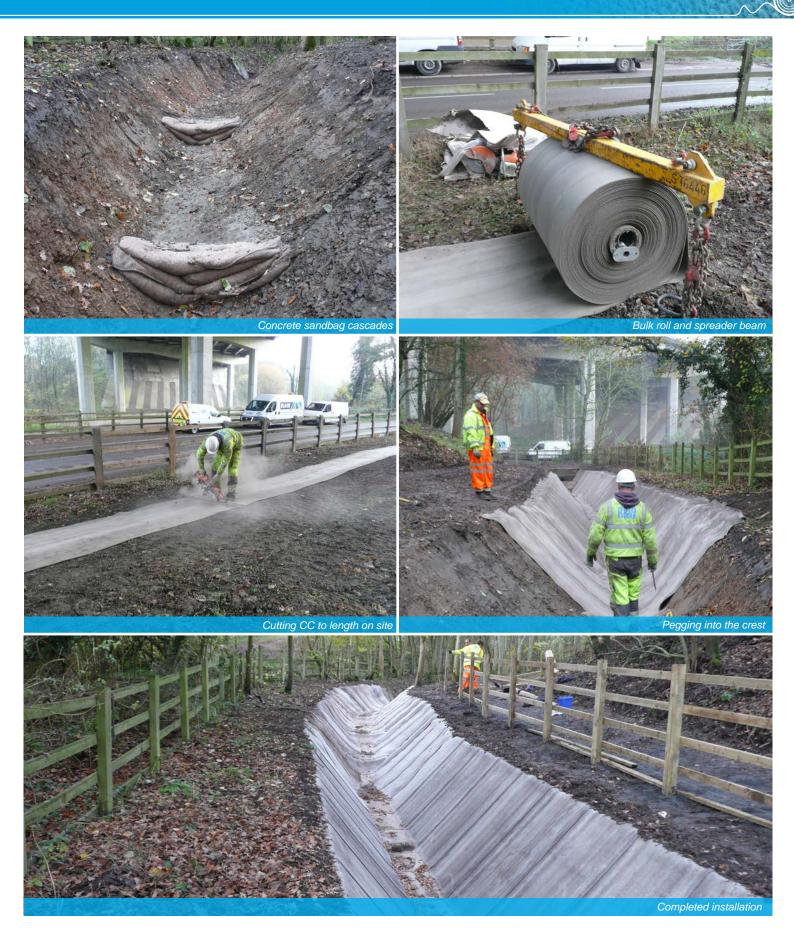
In November 2010, Concrete Canvas GCCM\* (CC) was used to line a ditch located adjacent to the M4 in Wiltshire, UK. The ditch needed to be cleared and was in dire need of repair. Originally a series of pipes and headwalls had been considered however there was concern over pipe blockages and future maintenance issues, so an alternative design was sought. CC provided a solution that prevented erosion, suppressed weed growth and eliminated the maintenance issues associated with blocked pipes. Additionally there was a key requirement to introduce a series of cascades that would reduce the water flow rate. CC enabled simple and cost effective cascades to be constructed using concrete sandbags, over which the CC was easily laid.

The existing concrete ditch was cleared of any debris, such as rocks and vegetation, to ensure intimate contact between CC and the substrate, whilst a new section of ditch was excavated and graded to profile. A small anchor trench was created at each crest, before the cascades were constructed using concrete sandbags located every 3m along the base of the ditch. Bulk rolls of CC8™ were delivered to site and hung from a spreader beam which allowed the CC to be cut to specific profile length, avoiding wastage. The CC was then laid transversely across the ditch with a 100mm overlap between layers. The CC was pegged into the anchor trench through every overlap, but the overlaps themselves were not sealed so as to create weep paths that would prevent the build up of hydrostatic pressure behind the material. Holes were cut into the CC to accommodate inlet pipes and other existing infrastructure. After hydration, the anchor trenches were backfilled to prevent water ingress under the CC.

The project was deemed a success and the speed and ease of install allowed a 20 linear metre section of ditch to be laid by a team of 3 in just 1 day.

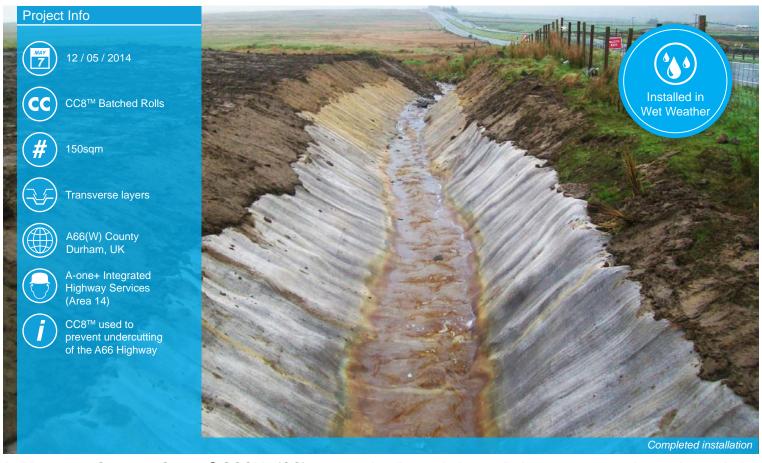
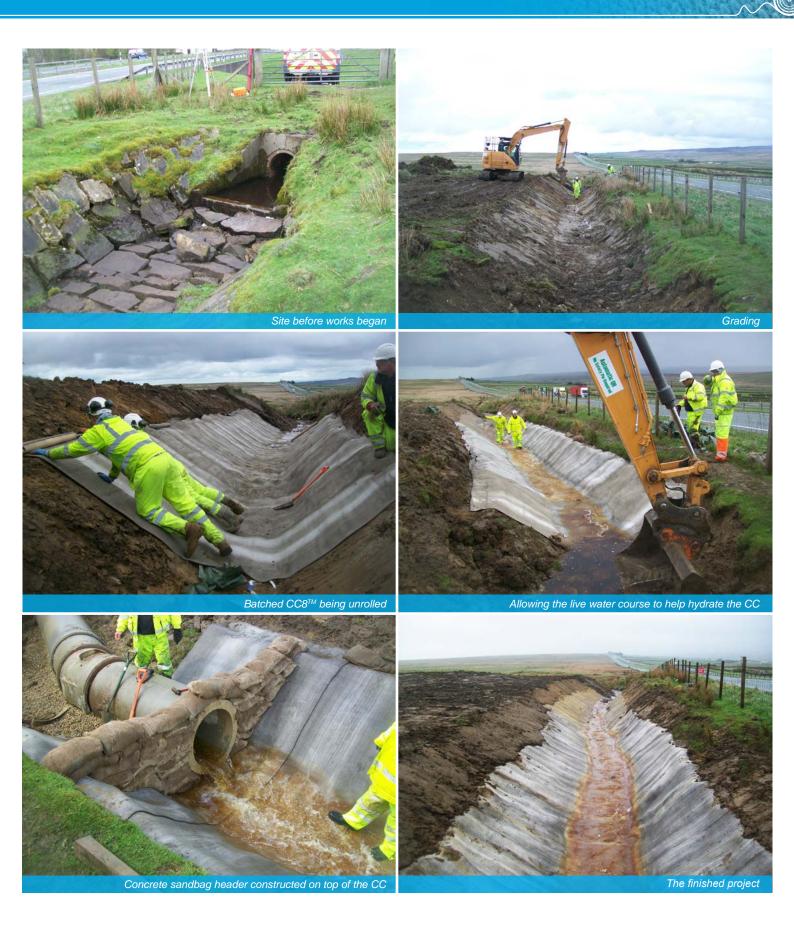
In May 2014, Concrete Canvas® GCCM\* (CC) was used to line a drainage ditch to prevent erosion underneath the nearby A66 highway. It was not possible to stop or divert the water due to weather conditions so a solution that could be installed in a live water course was paramount. At the top of the ditch there was a termination of a culvert which needed to be accommodated.

Installation was carried out by A-one+ Integrated Highway Services (Area 14). An excavator was used to re-profile the ditch and culvert before 30 batched rolls of CC8™ were delivered to site. The excavator transported the batched rolls to sections of the ditch as required before they were unrolled by hand into position. The CC was laid progressively upstream, and pegged at the edges whilst allowing the live water course to flow under the material. Once the CC had been installed along the length of the ditch, a concrete sandbag header wall was built on top of the last CC layer. This would allow the water from the culvert to flow over the CC as intended. The overlaps were mechanically jointed with screws at 200mm centres; the joints weren't sealed so as to create natural weep paths allowing water ingress into the ditch and preventing the build-up of hydrostatic pressure behind the CC. Post hydration, the anchor trenches along the crest were backfilled to secure the CC in place and to provide a neat finish.

150sqm of CC8™ were installed by 6 people in 2 days during torrential rain and in a live water course.

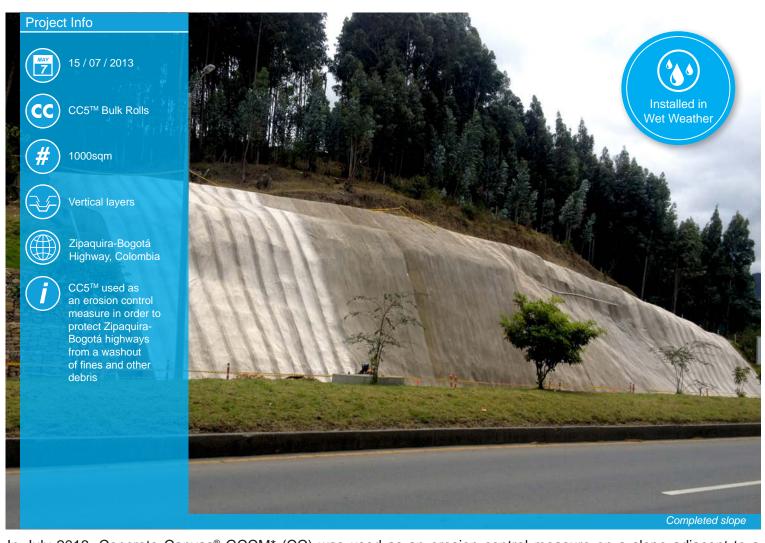
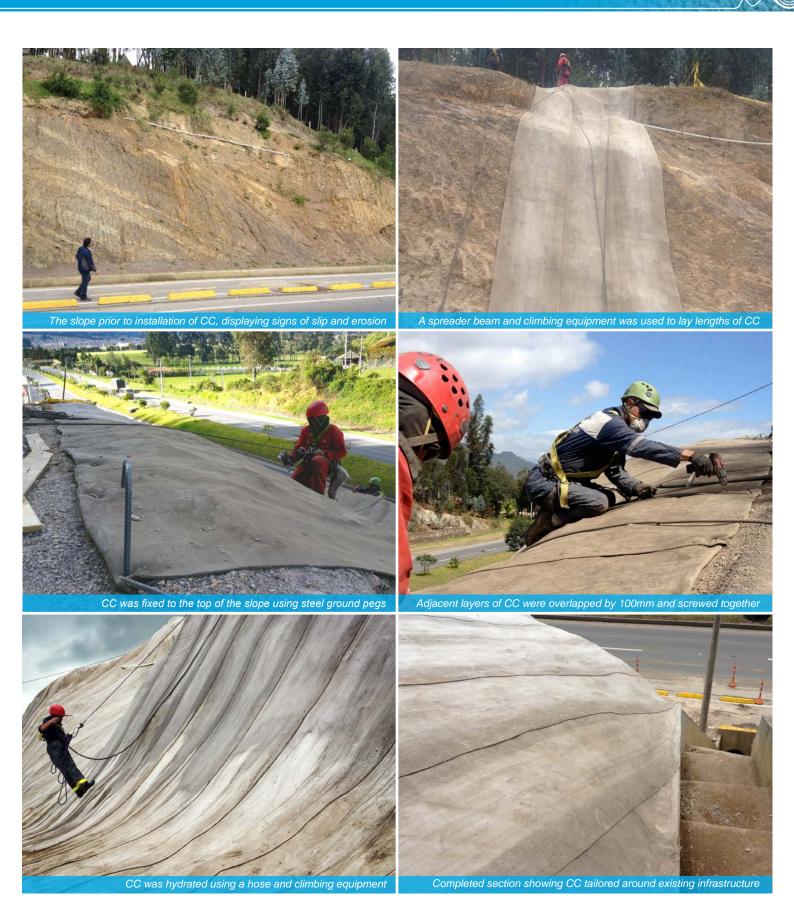
In July 2013, Concrete Canvas® GCCM\* (CC) was used as an erosion control measure on a slope adjacent to a section of the Zipaquira-Bogotá Highway in Chinchilla, Colombia. The slope had suffered from slip and the erosion of fines due to adverse weather in the region, a situation exacerbated by leakage from a water pipe that had been installed across a significant section of the slope. There was potential for falling debris to cause an accident on the highway, or block the cycle path that ran alongside it. Shotcrete had been considered for the project. However, there was a concrern that the associated rebound may cause damage to the highway and surrounding infrastructure.

Prior to installation the area affected was cleared of vegetation, loose soil and rock and other debris. Bulk rolls of CC5™ were then delivered to site and cut to length, ensuring that the CC could cater for the slope's varying profile whilst eliminating material wastage. Each length of CC was fixed to the top of the slope using 400mm steel ground pegs before being unrolled down the slope using a spreader beam and climbing equipment. Adjacent lengths of CC were overlapped by 100mm and screwed together at 200mm. Anchor bolts were used to fix the material to the foot of the slope and to the drainage outlet at one end of the slope. The installed CC was then hydrated.

The 1000sqm installation was completed in 13 days in inclement weather by an installation team of 6. The client and installation team were impressed with the ease and speed at which CC was installed, as well as the material's "consistency and functionality". Feedback provided by the project's head engineer in November 2013 stated that, after two weeks of very heavy rain, the CC was still stable and the slope had not shown any movement or further loss of fines.

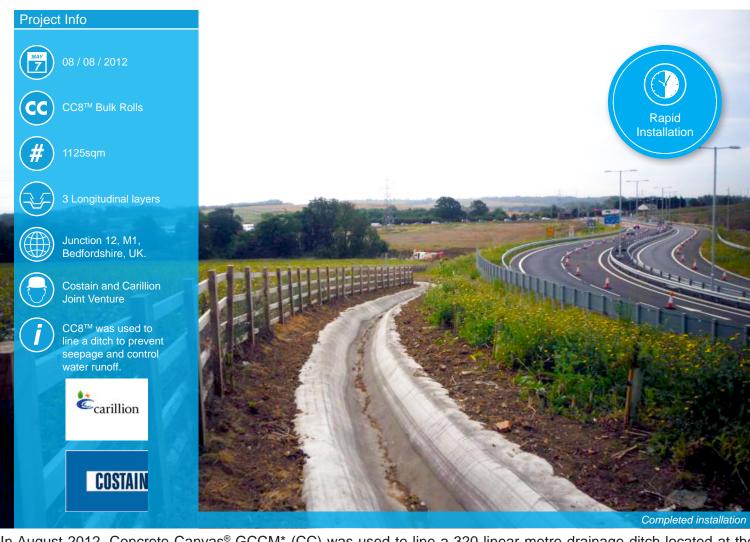
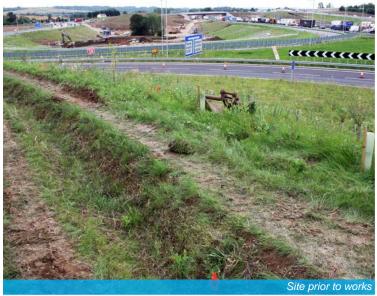
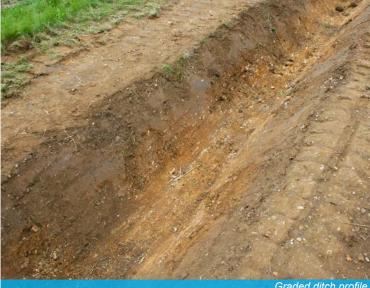
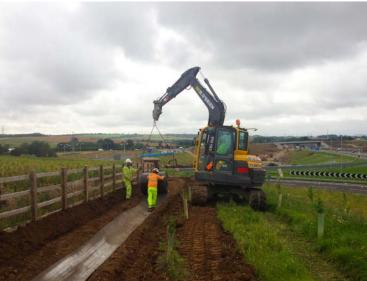
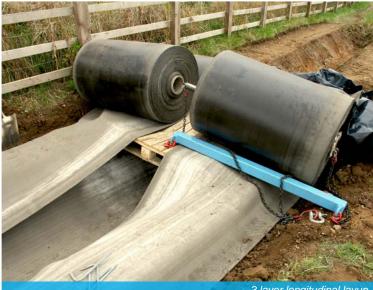
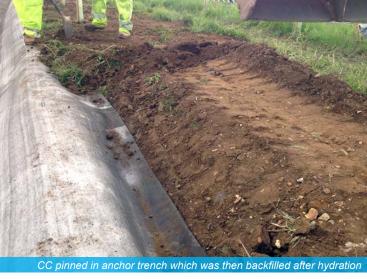
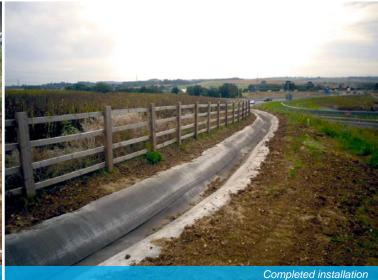
In August 2012, Concrete Canvas® GCCM\* (CC) was used to line a 320 linear metre drainage ditch located at the top of a motorway batter. There were issues regarding seepage and a requirement to control water runoff. The site is located at junction 12 of the M1 in Bedfordshire, UK. CC was specified over traditional concrete solutions due to the speed and ease of install and the site accessibility issues that would have made conventional concreting difficult and time consuming.

Installation was carried out by Costain and Carillion as a joint venture. The ditch was excavated using plant and V bucket combination, and anchor trenches were created on either side of the ditch. Bulk rolls of 8mm thick CC (CC8™) were delivered to site and unrolled using a spreader beam hung from an excavator. The CC was unrolled in 3 longitudinal layers with an overlap of 100mm. The CC was fixed to the substrate with ground pegs at approximately 2m centres along the crest of the ditch. After hydration, the anchor trench was backfilled to prevent water ingress under the CC8™.
